# Vehicle Service Intake & Diagnostic Sheet

Customer Concern, OBD-II Scan Data & Requested Tech Inspection

| 2010 Nissan Altima 2.5 | 1N4AL2AP5AN469579 | 178,665 Miles | QR25DE 2.5L DOHC (L32) |

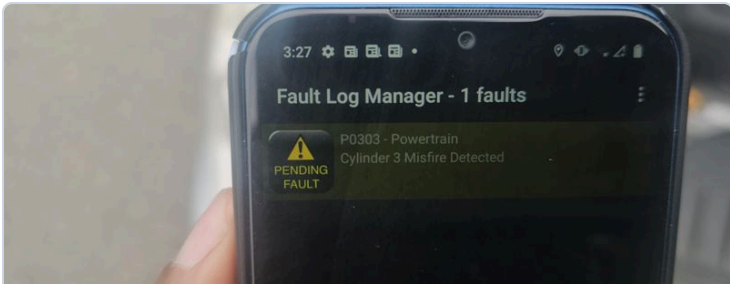
**Plate 1: OBD2 Scan - Torque Pro Fault Log**  
Confirmed active P0303 – Powertrain: Cylinder 3 Misfire Detected logged as a Pending Fault.

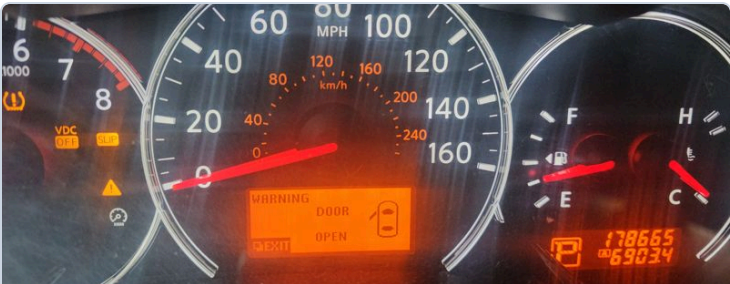
- DTC Stored:** P0303 – Cylinder 3 Misfire Detected (Logged as Pending DTC).
- Customer Concern:** Engine runs rough and shakes/shudders when idling at red lights; smooths out once driving at cruising speed.
- Dash Lights:** Instrument cluster has **VDC OFF** and **SLIP** lights illuminated. This is standard Nissan ECM behavior—the computer automatically disables traction control during an active engine misfire. Both lights clear once the misfire is fixed.

**Plate 2: Instrument Cluster Telemetry**  
178,665 verified miles. VDC OFF and SLIP indicators illuminated under ECM torque failsafe.

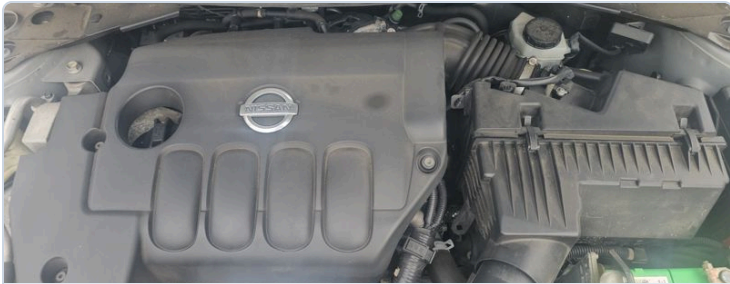
- Engine Family:** QR25DE 2.5L 16-valve 4-cylinder (California PZEV PC certified).
- Cylinder Order:** Numbered sequentially **#1 – #2 – #3 – #4** from passenger timing belt side toward the driver transaxle/battery.
- Target Cylinder:** Cylinder #3 is the 3rd cylinder from the passenger timing chain (2nd from the air cleaner box).

**Plate 3: QR25DE 2.5L Engine Bay Layout**  
Cylinders 1-4 left-to-right. Cylinder #3 is located under the 3rd contour runner of the engine cover.

- Check Tube #3 for Oil:** Pull Coil #3 and check the rubber boot for engine oil. On this 2.5L QR25DE, the valve cover tube seals leak oil into the spark plug wells over time.
- Coil Swap Test:** Swap **Coil #3 over to Cylinder #2**. Clear code and see if the miss follows the coil to P0302. If it does, replace the coil.
- Spark Plug Condition:** Pull plug #3 (5/8" / 16mm socket). Check electrode wear and gap. At 178k miles, recommend replacing the full set of 4 NGK Laser Iridium plugs (DILKAR6A11).
- Injector / Wiring Check:** If the miss stays on #3 with a known-good coil and plug, check injector resistance (spec: **11.4 – 12.6 Ω**) and harness wiring.
- Secure Battery Clamp:** The metal battery hold-down clamp is disconnected and resting loose across the tray near the ECM harness. Please clean and bolt it down.

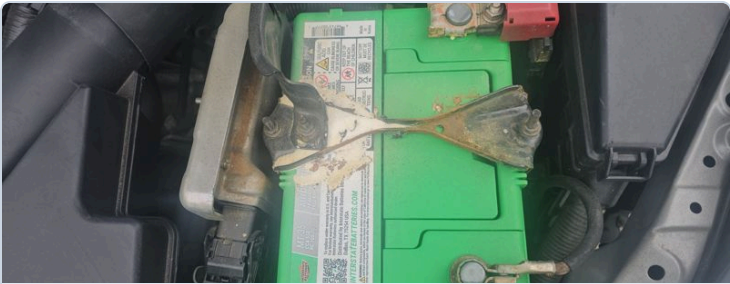
**Plate 4: Battery & ECM Mounting Proximity**  
Corroded tie-down bracket resting loose across battery. Check ECM casing & wire harness directly adjacent.

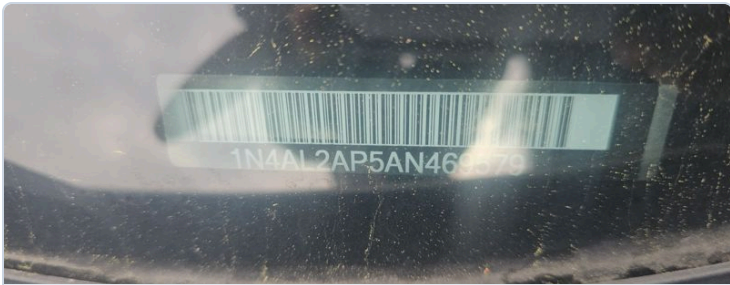
**Plate 5: Official Vehicle Identification Number (VIN)**  
1N4AL2AP5AN469579 (2010 Nissan Altima 2.5 Sedan, Canton MS Assembly Plant).

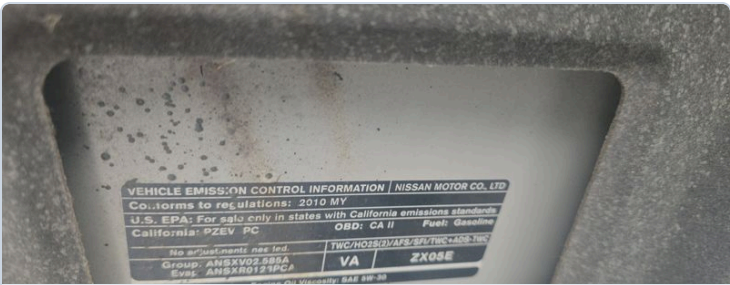
**Plate 6: Underhood Emissions Certification**  
2010 MY Nissan California PZEV PC certification (Group: ANSXV02.585A, SAE 5W-30 oil specification).
